## Home Inspection Report

28 Abbott Square,  
Birmingham AL 35242

**Crawford & Associates Inspections**

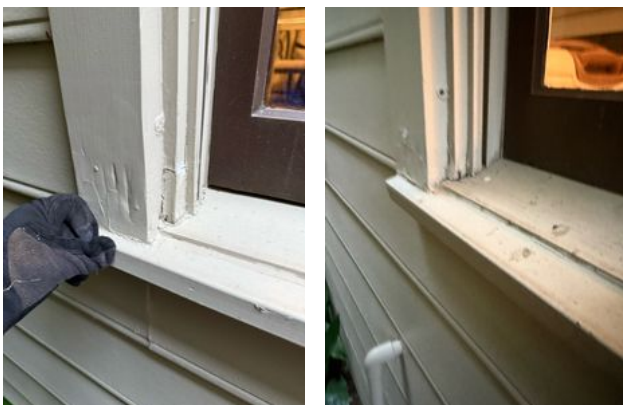
Implication: While active moisture penetration was not evident at the time of inspection, deteriorated trim can allow water intrusion over time, potentially leading to concealed damage to wall components if not addressed.

Recommendation: Recommend further evaluation/repair or replacement of the affected window trim by a qualified carpentry professional prior to closing.

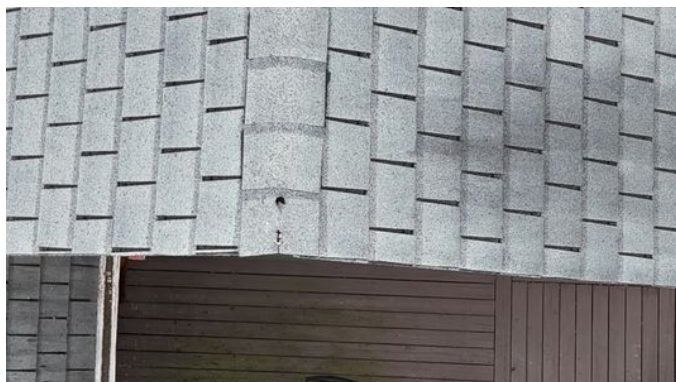
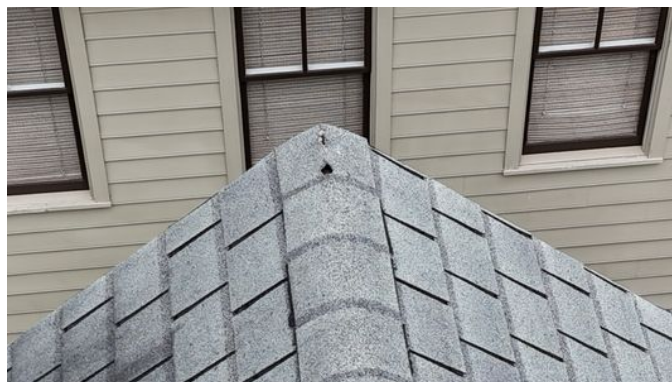
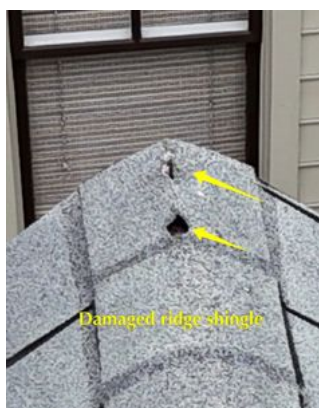
Implication: Damaged shingles can increase susceptibility to wind damage and water intrusion.

Recommendation: Recommend further evaluation by a qualified roofing contractor to determine repair or replacement options and associated costs prior to closing.

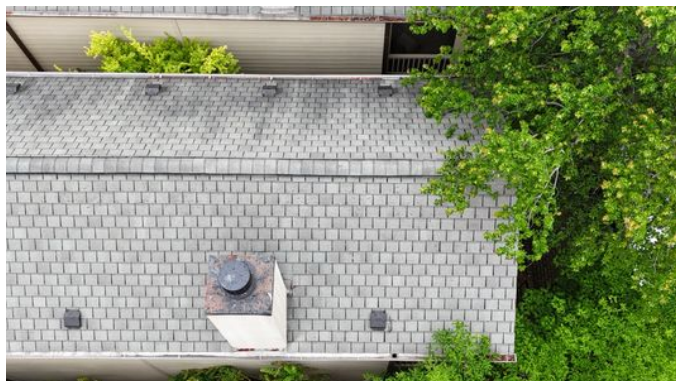
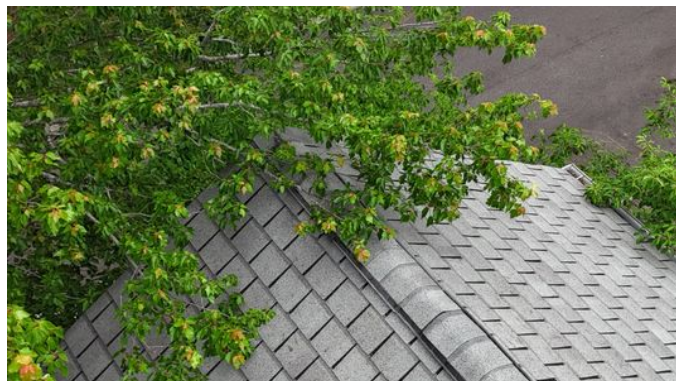
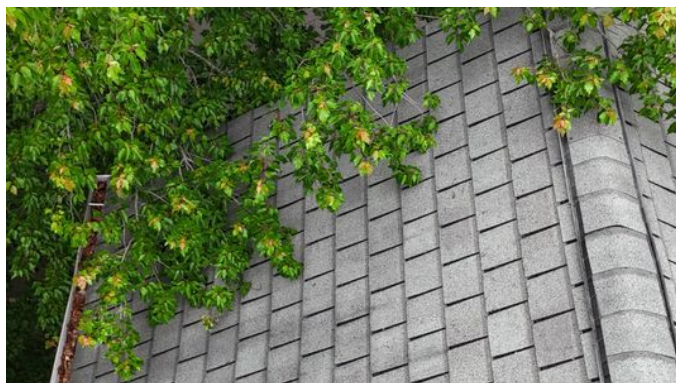
Implication: Contact with tree limbs can damage shingles, accelerate wear, and create pathways for moisture intrusion. Overhanging branches can also deposit debris into gutters, increasing the risk of clogs and improper roof drainage.

Recommendation: Recommend trimming tree limbs back from the roof covering by a qualified tree service contractor prior to closing or as part of ongoing maintenance.

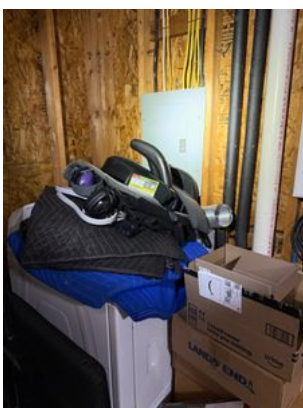
Implication: Conditions or defects may exist within concealed or obstructed areas that were not observable at the time of inspection.

Recommendation: Recommend further evaluation of the panel condition by a licensed electrical contractor prior to closing.

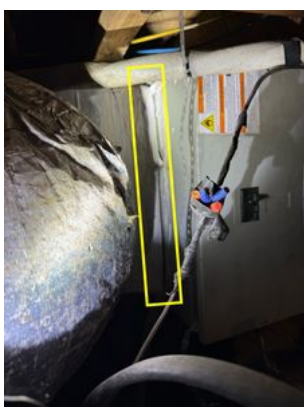
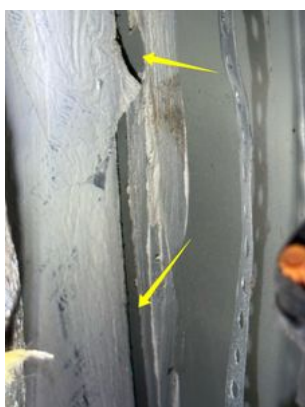
Implication: Unsealed duct connections can allow unconditioned, contaminated crawlspace air to enter the living space, potentially affecting indoor air quality, system efficiency, and occupant comfort. Moisture and debris within HVAC components may further contribute to microbial growth, odors, and reduced system performance if not addressed.

Recommendation: Recommend further evaluation, sealing of duct connections, and professional cleaning of affected HVAC components by a licensed HVAC contractor. Corrections should be completed prior to closing to improve air quality, system efficiency, and proper operation.

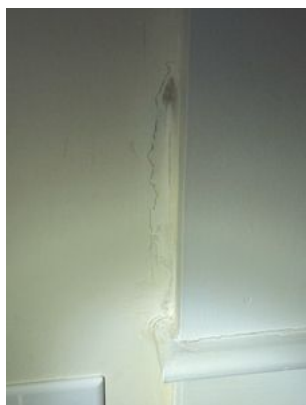
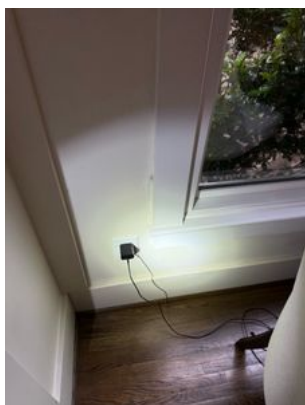
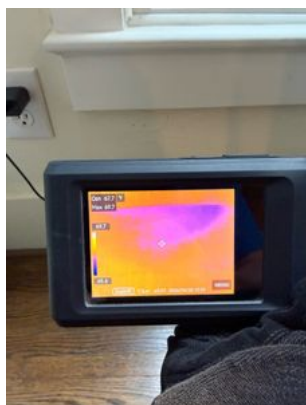
Implication: Moisture intrusion can lead to concealed deterioration of surrounding materials and may contribute to microbial growth if not addressed.

Recommendation: Recommend further invasive evaluation to determine the extent of concealed damage and correction by a qualified carpentry contractor prior to closing.

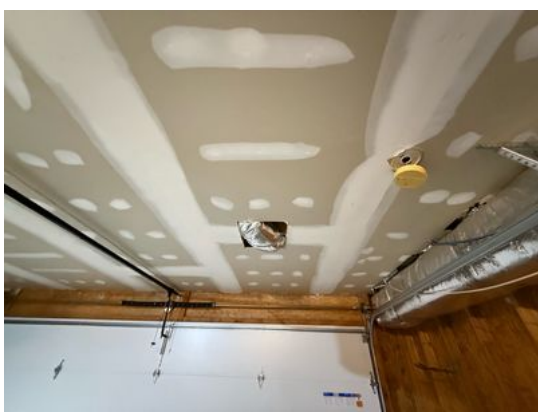
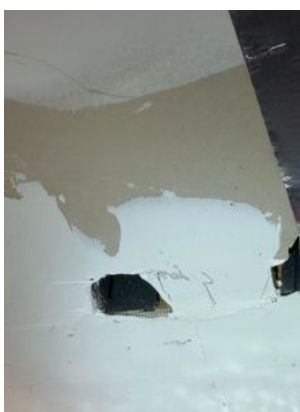
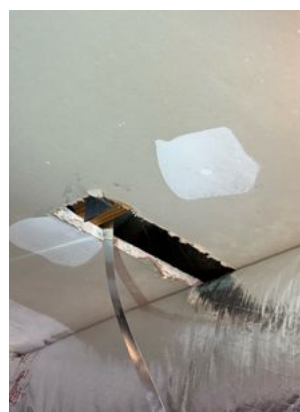
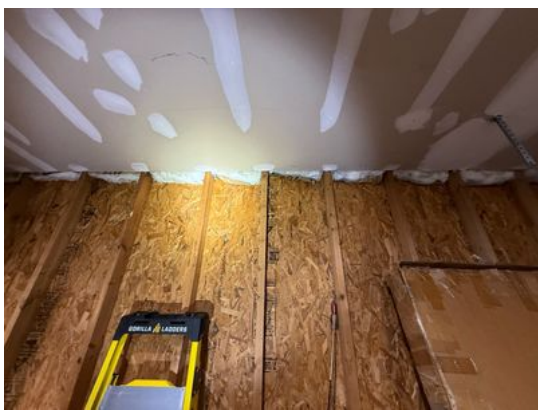
Openings and breaches were noted in the garage ceiling drywall beneath finished living space, which may compromise the intended fire-resistive separation between the garage and the habitable area above. This condition may allow the passage of smoke, fire, or gases through the assembly and does not appear consistent with current residential standards.

Recommendation: Recommend further evaluation by a qualified drywall contractor to determine needed repairs and provide completion/repair cost estimates prior to closing. Corrections should include proper repair and sealing of penetrations as needed to help restore the intended fire separation.

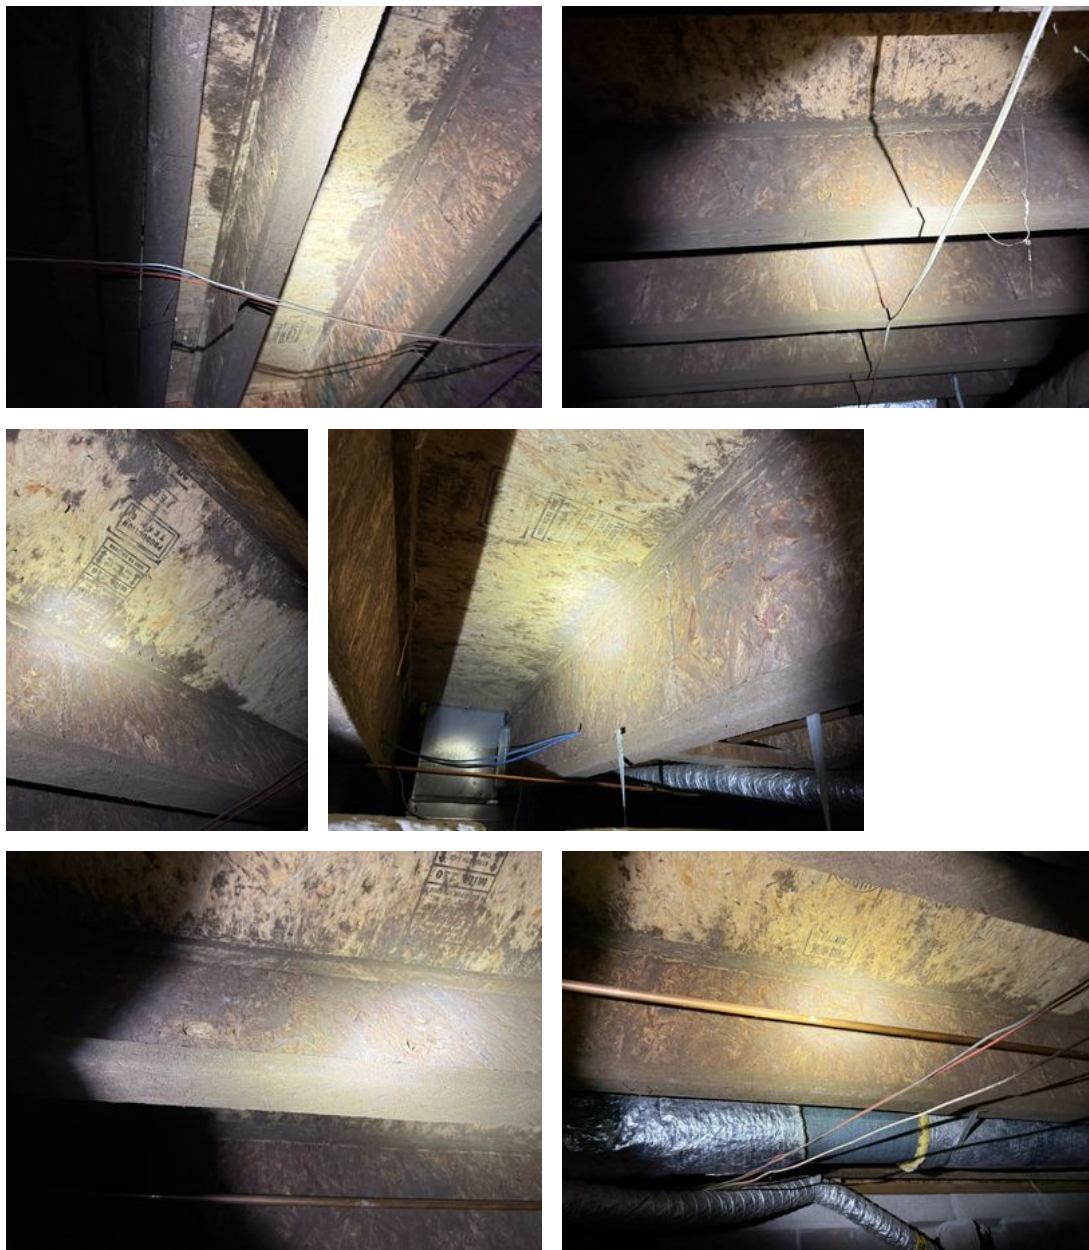
Implication: Microbial growth may be associated with prior moisture exposure, can contribute to material deterioration over time, and may affect interior air quality.

Recommendation: Recommend further evaluation and remediation, as needed, by a qualified contractor, along with exploration of moisture control improvements, including possible crawlspace encapsulation options if preferred, prior to closing and occupancy.
