## Home Inspection Report

28 Abbott Square,  
Birmingham AL 35242

**Crawford & Associates Inspections**

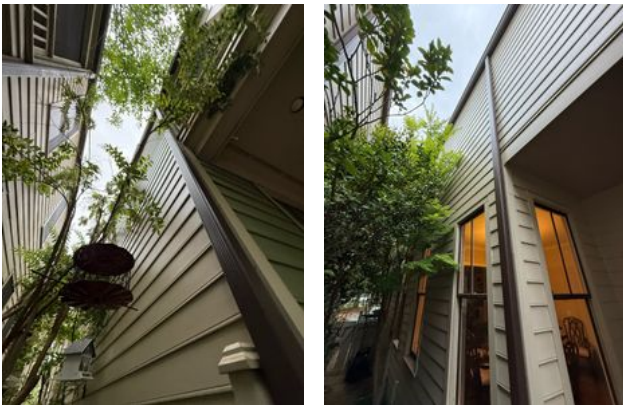
Growing Against Structure

Condition: General Maintenance

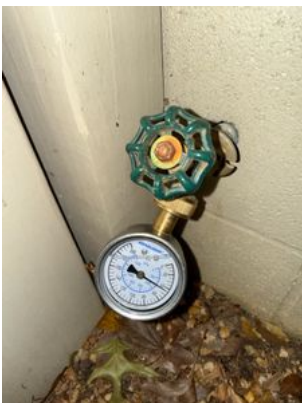
Condition: Repair/Replace as needed

An exterior hose bib (front right) was observed to be not properly secured to the structure, as is recommended by contemporary plumbing standards. A loose hose bib increases the likelihood of pipe movement and stress on plumbing connections, which can lead to leaks over time.

Recommend correction at any exterior hose bibs as needed, by a licensed plumbing contractor prior to closing.

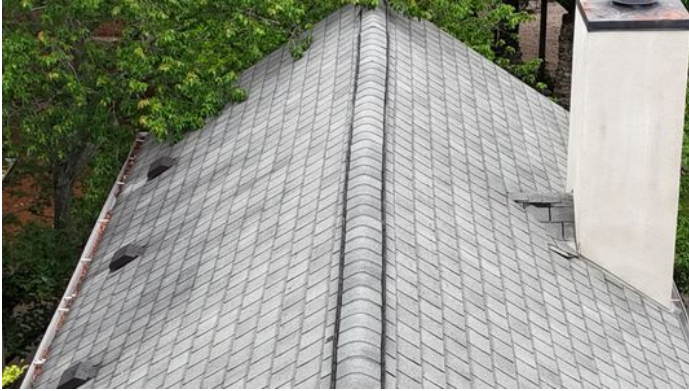
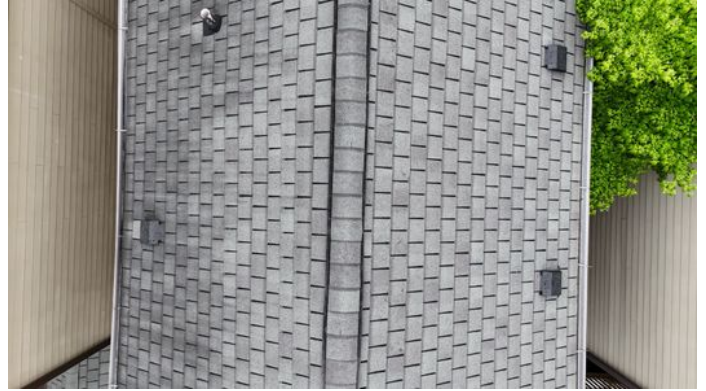
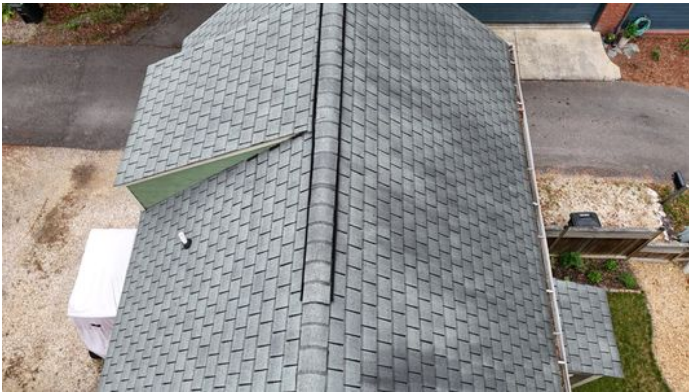
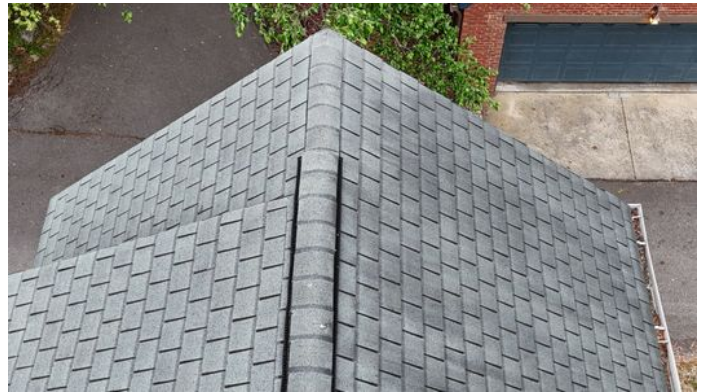
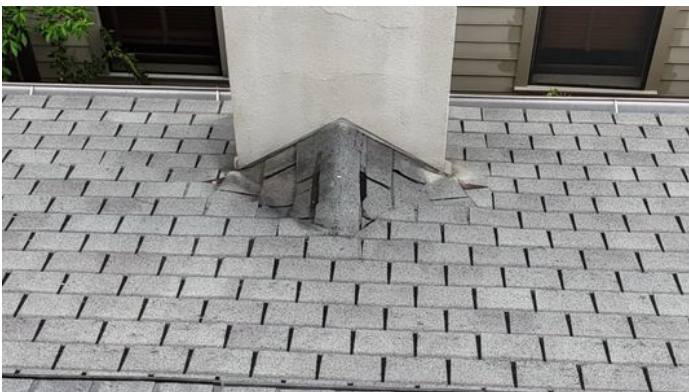
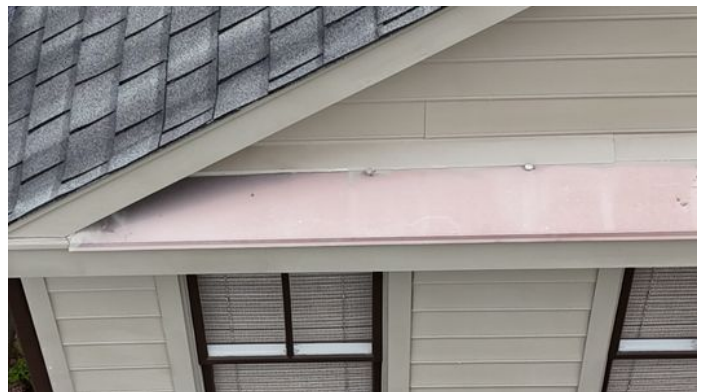
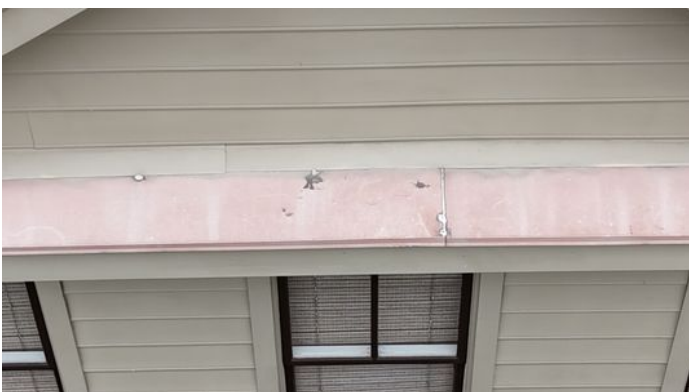
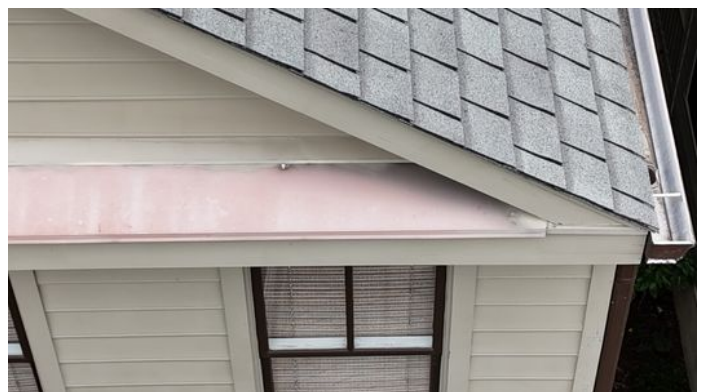
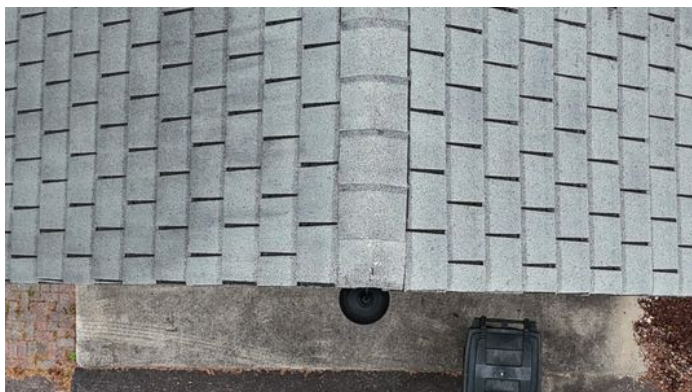
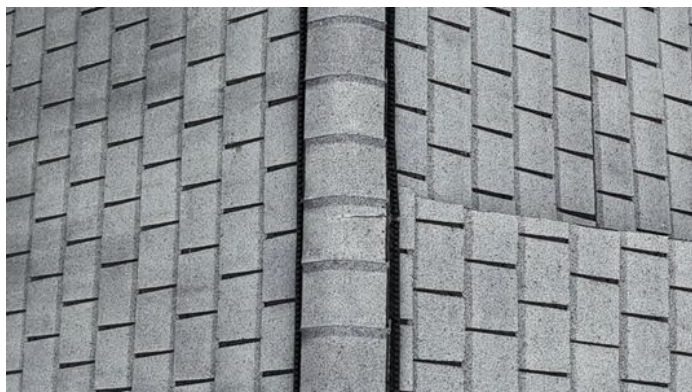
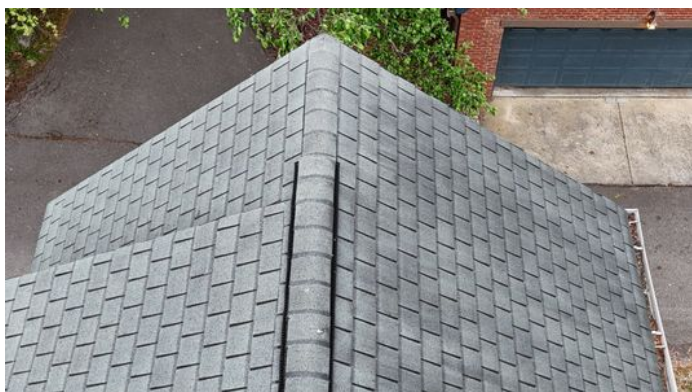
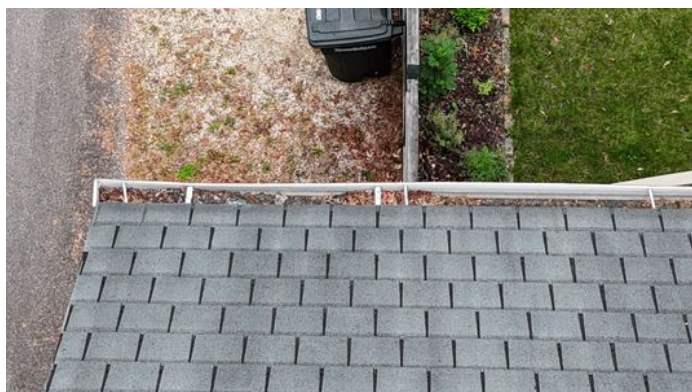
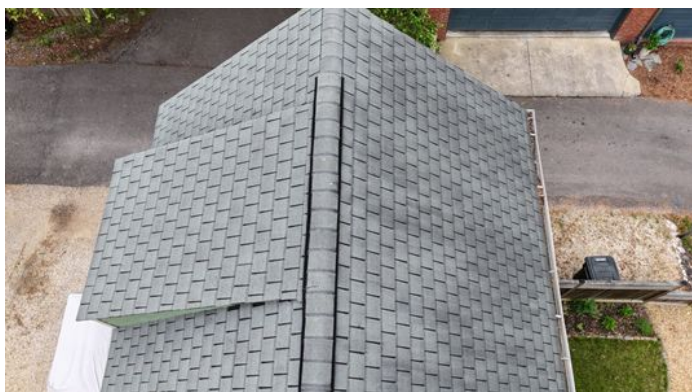
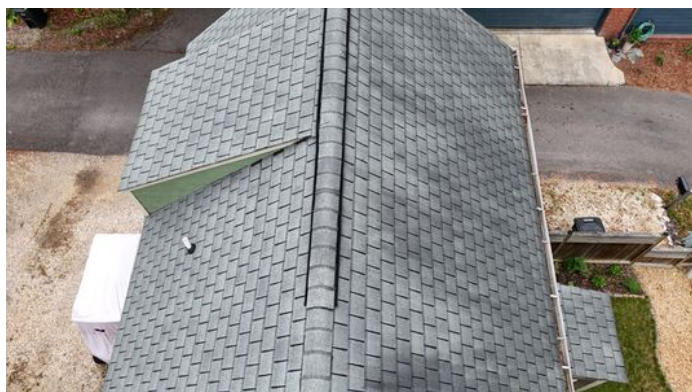
Observation: Damaged, cracking and torn ridge shingles were noted at the time of inspection.

Explanation: Portions of the roof covering showed physical deterioration and loss of integrity.

Implication: Damaged shingles can increase susceptibility to wind damage and water intrusion.

Recommendation: Recommend further evaluation by a qualified roofing contractor to determine repair or replacement options and associated costs prior to closing.

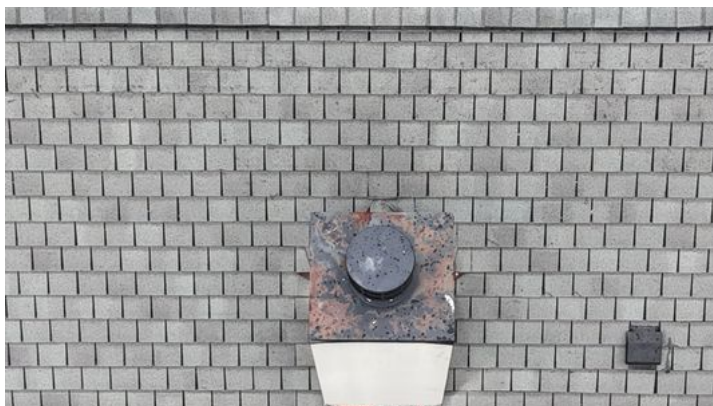
#### Comment 6

Chimney Caps – Rust / Corrosion Observed

Both chimney caps displayed significant rust and corrosion at the time of the inspection.

Advanced corrosion can lead to thinning metal and eventual pinhole development. This condition may allow moisture intrusion into the chimney flue system, contributing to deterioration of masonry components, flue liners, and interior finishes over time.

Recommend further evaluation by a qualified chimney contractor to determine whether cleaning and application of rust-inhibitive coating is appropriate. Corrections are recommended prior to closing to help prevent continued metal cap damage.

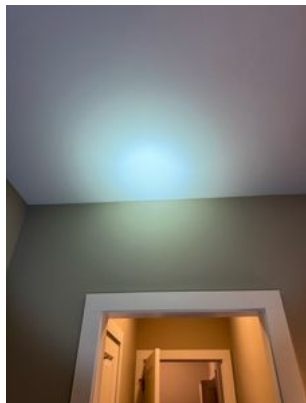
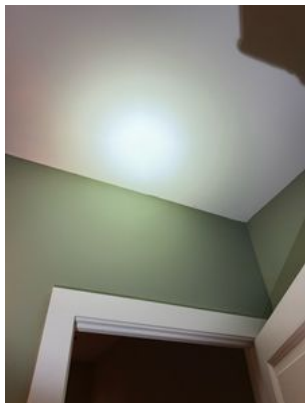
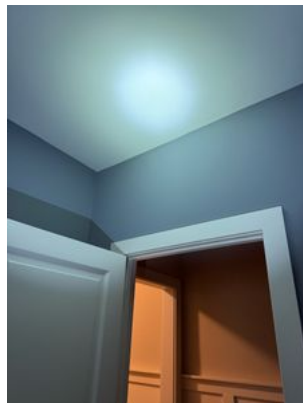
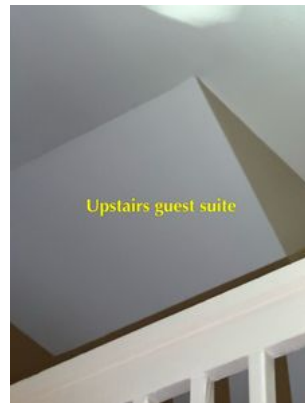
Smoke Detectors – Insufficient Coverage & Aged Unit Noted (main house)

Defect / Observation: An insufficient number of smoke detectors were observed in or near the sleeping areas of the home. Additionally, the smoke detector located in the garage appeared to have surpassed its expected service life.

Implication: Contemporary residential safety standards recommend smoke detectors in each sleeping area and adjacent hallways to provide early warning in the event of a fire. Smoke detectors beyond their typical 10-year lifespan may not function reliably, reducing overall fire safety.

Recommendation: Recommend installation of additional smoke detectors to provide proper coverage of all sleeping areas and adjoining hallways. Also recommend replacing the aged smoke detector in the garage with a new, 10-year sealed lithium battery unit or other approved device. Improvements should be completed prior to closing to enhance occupant safety.

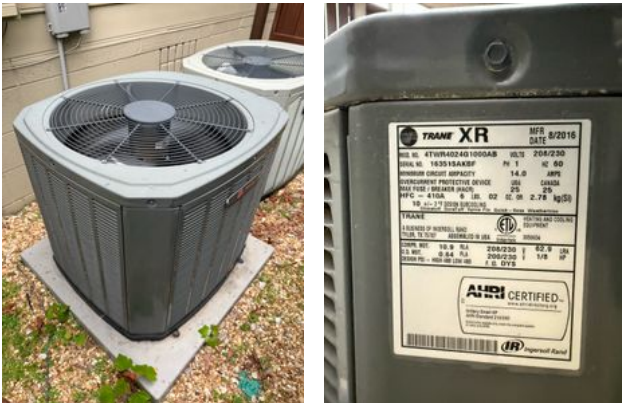
#### Comment 14 Information

Equipment Type: Heat Pump Condensing Unit

This unit is beyond the 7-year threshold where increased attention to maintenance is prudent. While age alone does not indicate replacement is needed, routine servicing becomes increasingly important to support reliability and efficiency.

If the system has not been serviced within the past year, a full professional HVAC service and cleaning is recommended prior to closing. Routine maintenance helps promote efficiency, reliability, and may help extend service life.

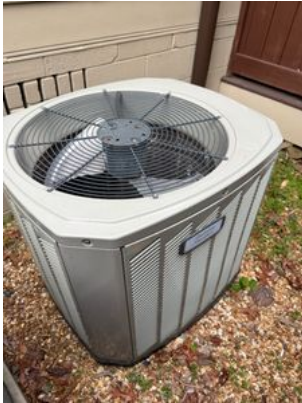
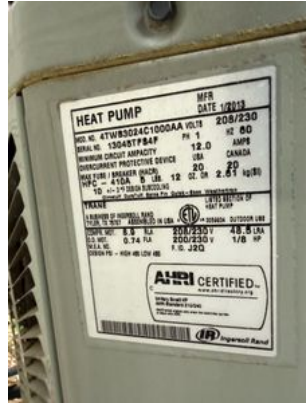
Due to age, the system should be considered an older unit. While replacement is not implied solely based on age, increased potential for repairs, efficiency decline, or refrigerant-related service should be anticipated over time.

Because the unit is over 7 years old, a full professional HVAC service and cleaning is recommended prior to closing. Routine maintenance helps support efficiency, reliability, and may help extend remaining service life.

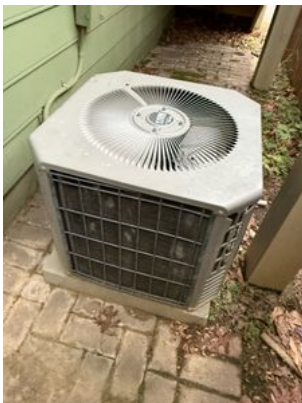
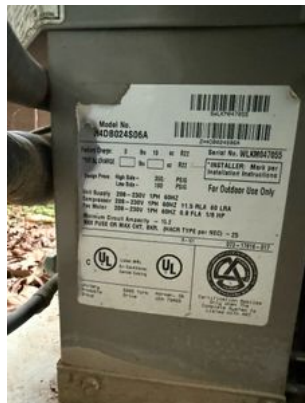
Equipment Type: Air Conditioning Condensing Unit

Typical service life for an air conditioning condensing unit is approximately 12–18 years. At approximately 21 years old, this unit is beyond typical expected service life.

This system uses R-22 refrigerant, an older refrigerant that has been phased out, which can make major repairs involving refrigerant or compressor replacement increasingly costly.

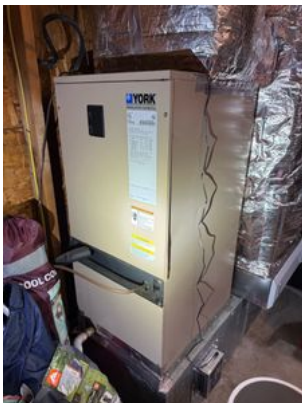
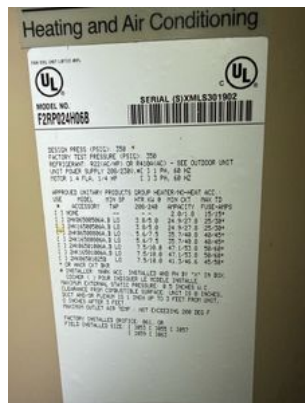
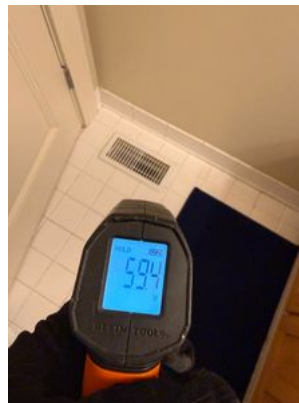
### Air Handler/Furnace 3

Because the indoor unit is older, attention should be given to evaporator coil condition, blower motor wear, drain management, and compatibility/match with the outdoor condenser. If paired with an R-22 system, future repair costs may be elevated.

Due to age, a full professional HVAC evaluation and service is recommended prior to closing. Budgeting for repair or replacement in the near term would be prudent.

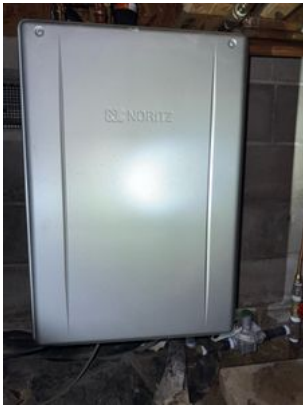
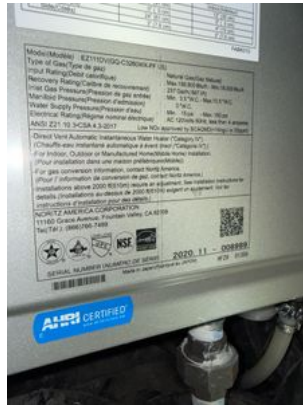
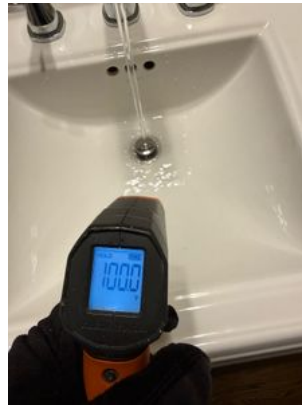
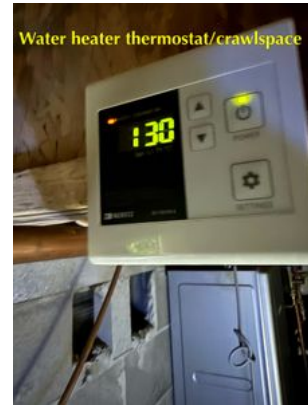
### Water Heater #1

Water heater thermostat/crawlspace

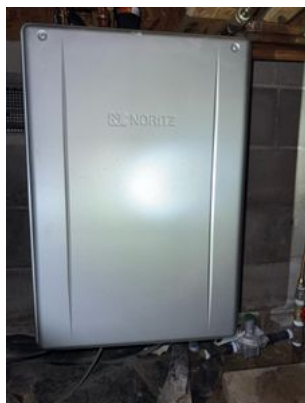
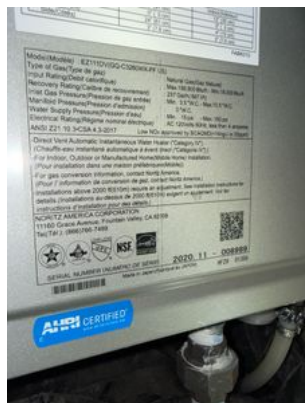
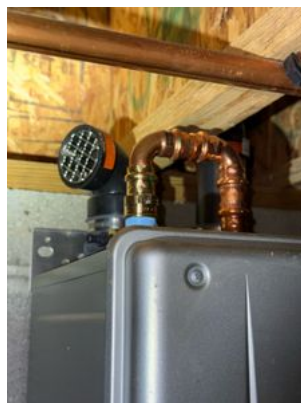
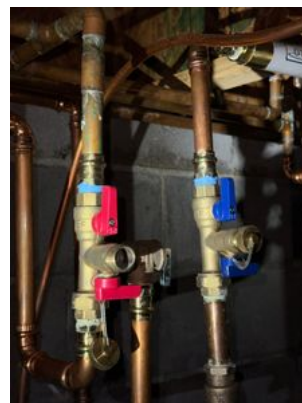
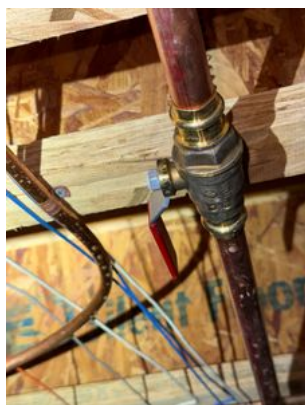
Tankless units benefit from periodic descaling/flushing, particularly where hard water conditions exist. Manufacturers commonly recommend routine maintenance to help preserve heat exchanger efficiency and extend service life.

If not serviced this calendar year, a full professional service is recommended prior to closing, including verification of flushing/descaling history. Routine maintenance helps support efficiency, reliability, and extend service life.

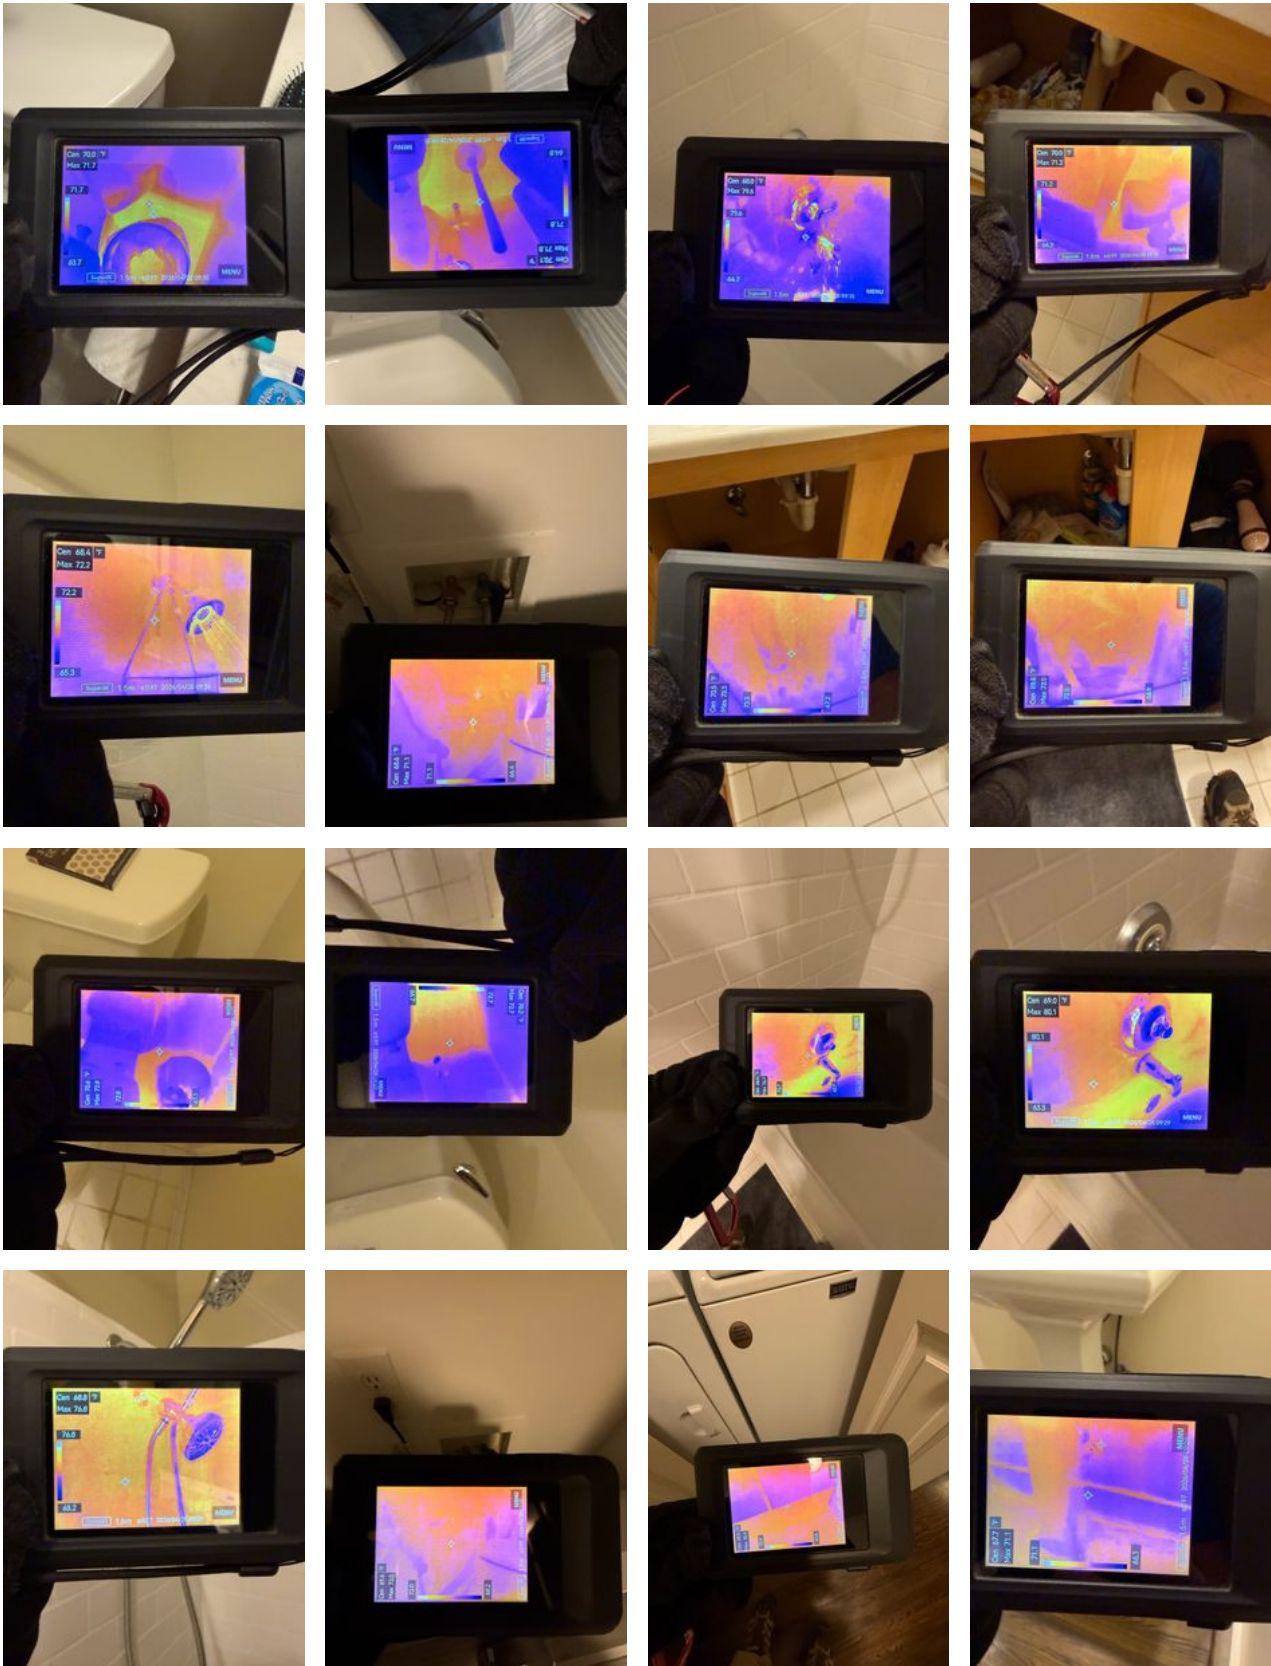
Thermal imaging did not confirm the presence of active leaks at the time of inspection around plumbing fixtures and other observed wet areas. It is important to note that thermal imaging provides only a snapshot in time. Hidden leaks, slow leaks, or intermittent leaks may not be detected during the inspection.

Recommend ongoing monitoring of these areas and consulting a licensed plumbing contractor if signs of moisture develop in the future.

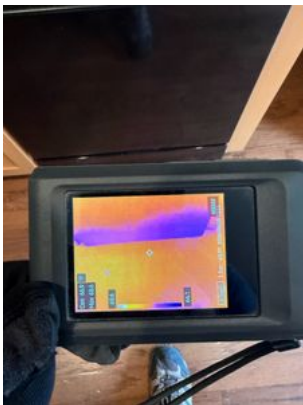
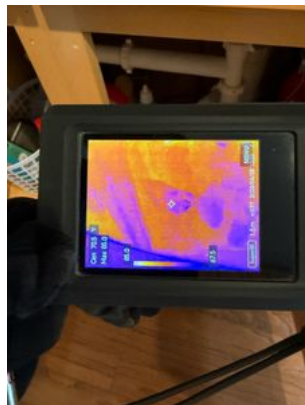
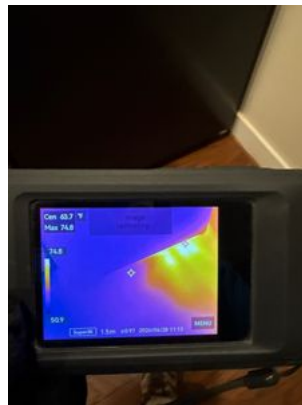
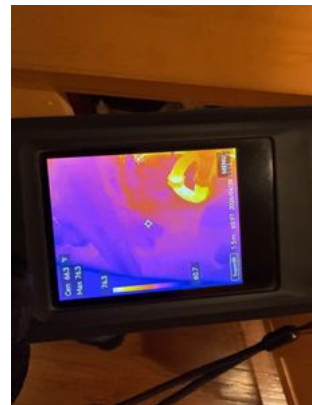
### Comment 30 Information

Thermal images from guest suite

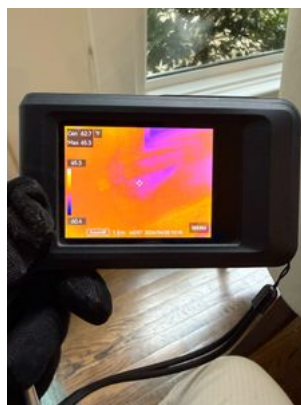
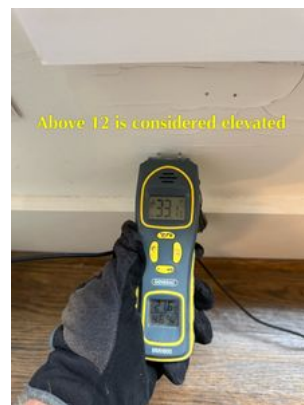
Observation: Moisture intrusion was confirmed at the large fixed window in the kitchen eat-in area using thermal imaging and moisture meter evaluation.

Explanation: Elevated moisture readings and thermal anomalies were noted consistent with active or prior water intrusion at the window assembly.

Implication: Moisture intrusion can lead to concealed deterioration of surrounding materials and may contribute to microbial growth if not addressed.

Recommendation: Recommend further invasive evaluation to determine the extent of concealed damage and correction by a qualified carpentry contractor prior to closing.

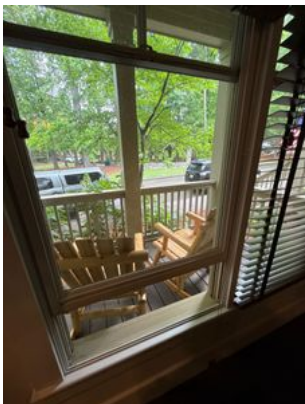
The window was damaged/not operating handles or hardware. Missing hardware can limit operability, compromise security, and reduce ease of use.

Recommend installation of appropriate replacement hardware by a qualified contractor to restore proper function.

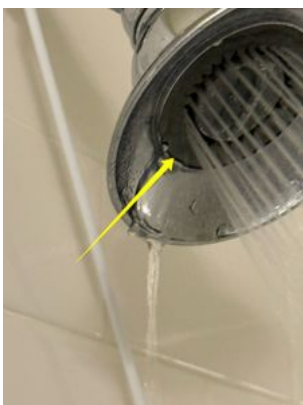
Bathroom Fixture Leak (upstairs Jack and Jill shower head)

A bathroom fixture was observed to be leaking. Leaks can lead to water damage, deterioration of finishes, or mold growth if not corrected.

Recommend repair of the leaking fixture by a licensed plumbing contractor.

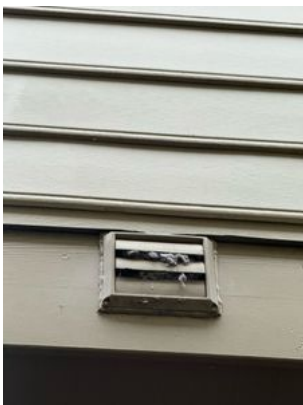
Observation: Significant lint buildup was observed at the dryer vent.

Implication: Restricted airflow can reduce dryer performance and represents a potential fire hazard if not corrected.

Recommendation: Recommend professional cleaning and further evaluation of the dryer vent system by a qualified contractor prior to closing, along with periodic maintenance thereafter to help ensure safe operation.

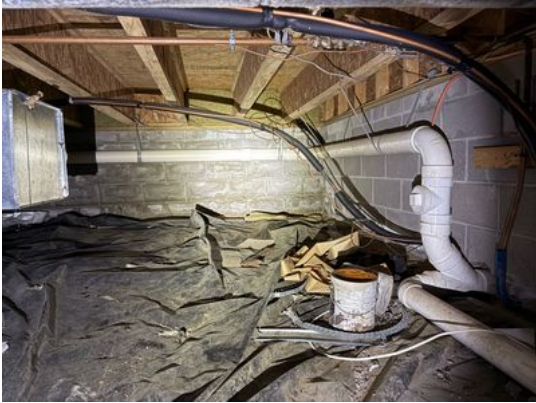
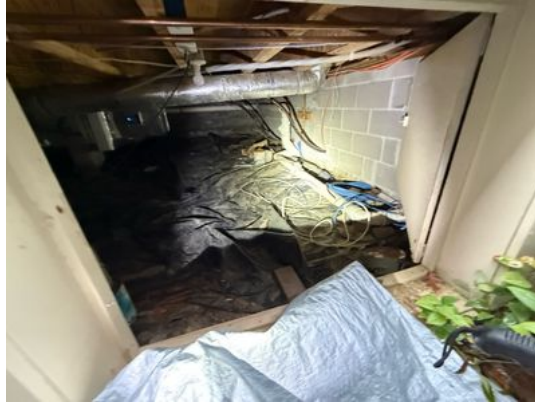
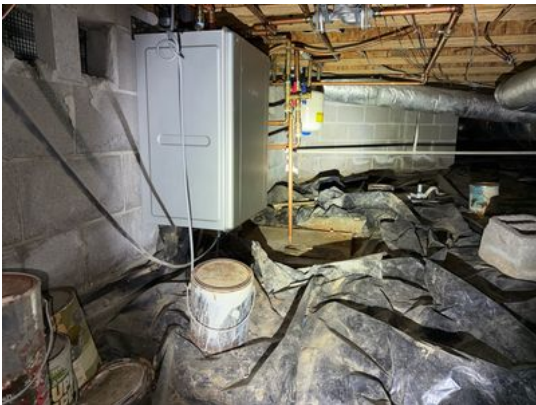
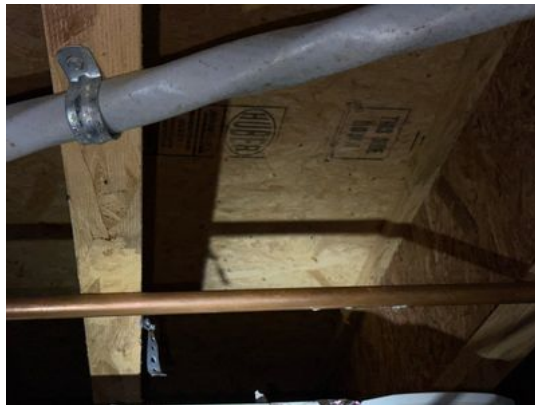
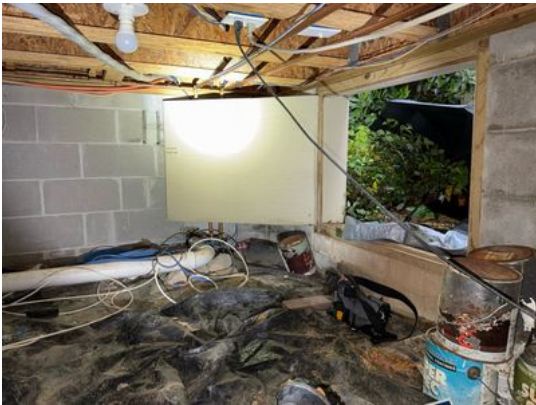
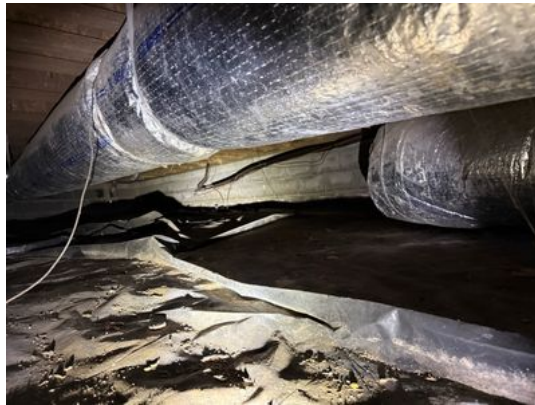
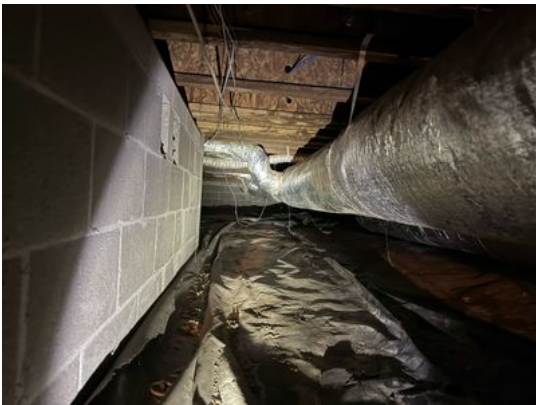
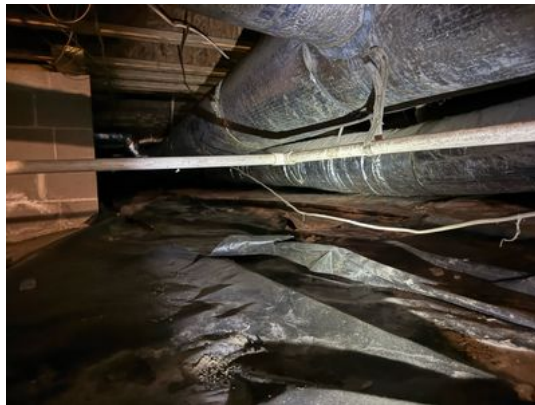
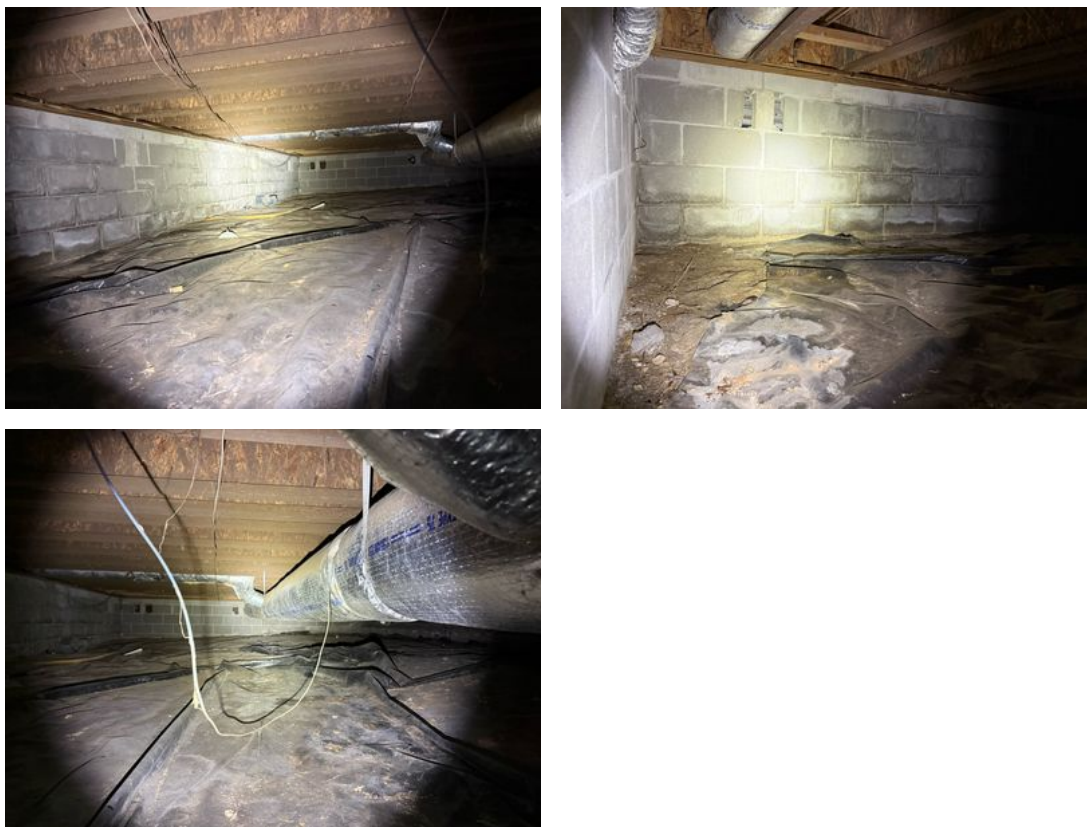
Observation: Microbial growth was observed on portions of wood structural components in the crawlspace, primarily near the center-front area of the home.

Explanation: Surface organic growth and discoloration were noted consistent with moisture-related conditions, although the crawlspace appeared dry at the time of inspection.

Implication: Microbial growth may be associated with prior moisture exposure, can contribute to material deterioration over time, and may affect interior air quality.

Recommendation: Recommend further evaluation and remediation, as needed, by a qualified contractor, along with exploration of moisture control improvements, including possible crawlspace encapsulation options if preferred, prior to closing and occupancy.

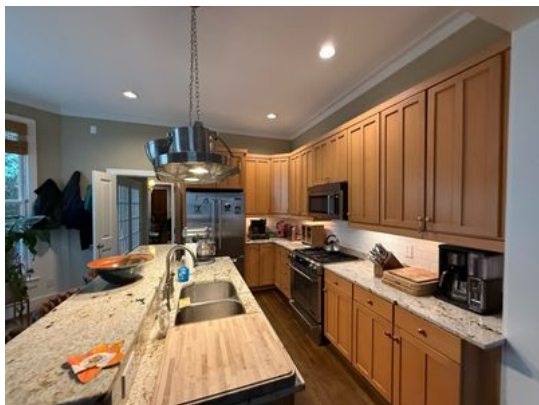
### Comment 41 Information

The kitchen sink disposal was smoothly operational as desired.

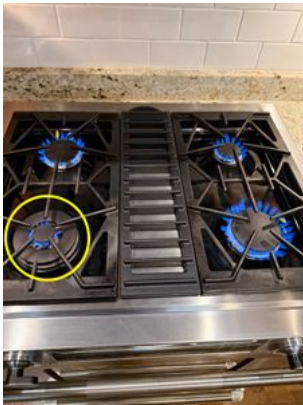
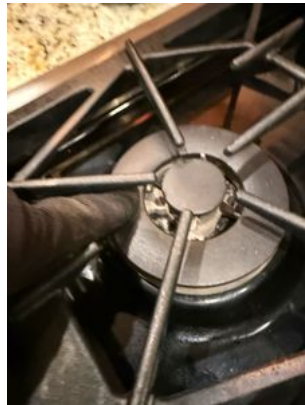
#### Comment 42

Observation: A suspected improper flame diverter was noted at the front left burner of the gas range.

Explanation: The burner component appeared improperly configured or positioned, which may be affecting normal flame distribution and burner performance.

Implication: Improper burner performance can affect cooking function and may indicate a component issue requiring correction.

Recommendation: Recommend further evaluation and repair by a qualified appliance technician prior to closing.

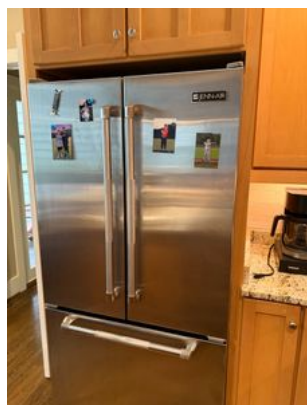
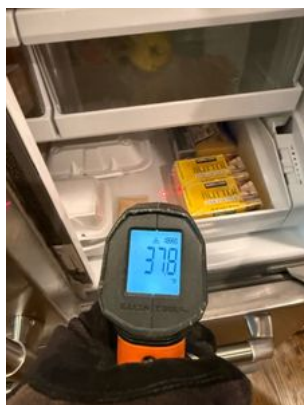
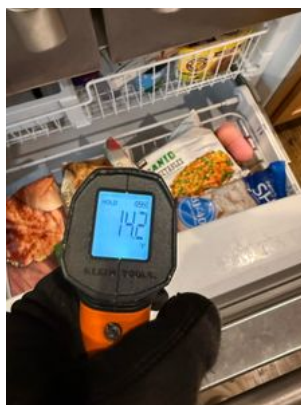
Jenn-Air

Condition: Satisfactory

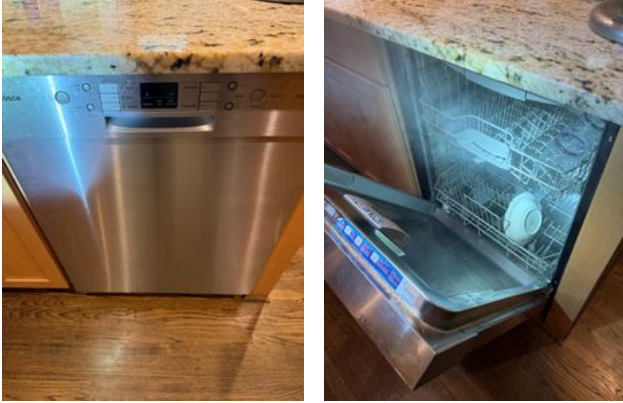
### Dishwasher

Bosch

Condition: Satisfactory

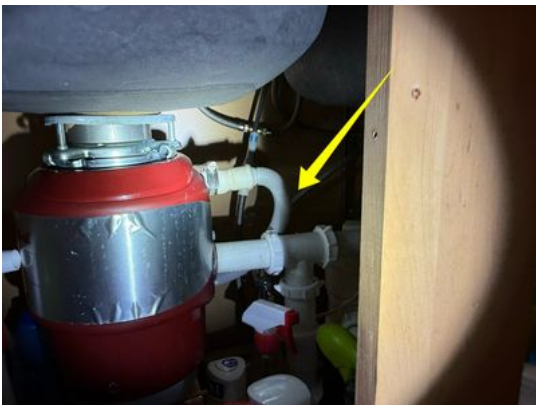
### High Loop Present

Yes

Condition: Marginal

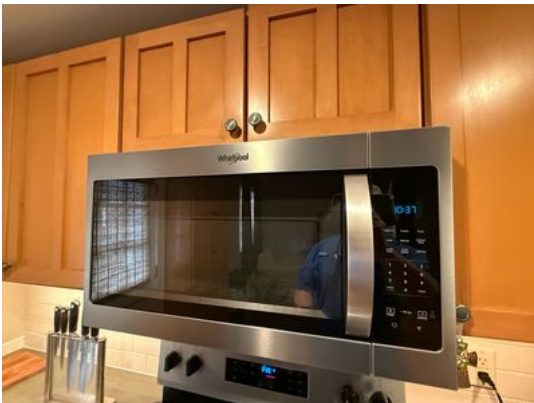
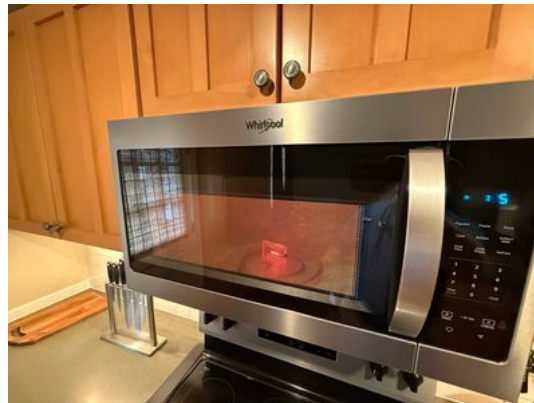
Whirlpool

Condition: Satisfactory

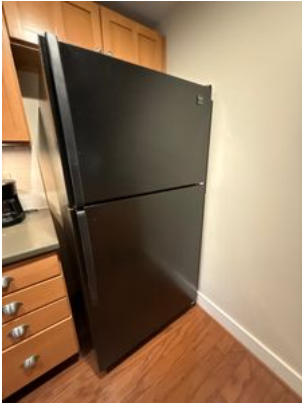
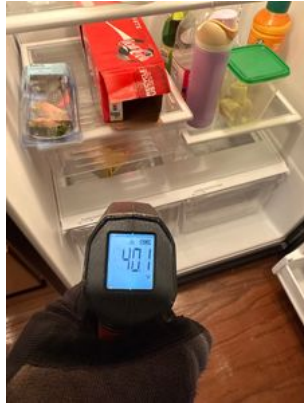
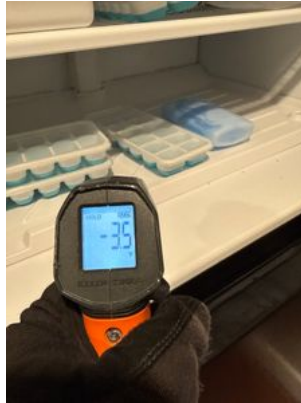
### Refrigerator

Whirlpool

Condition: Satisfactory

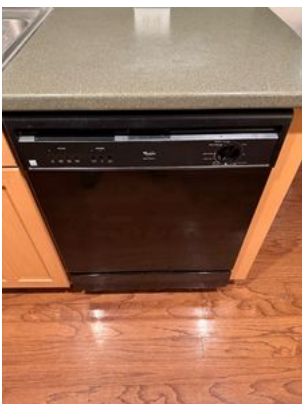
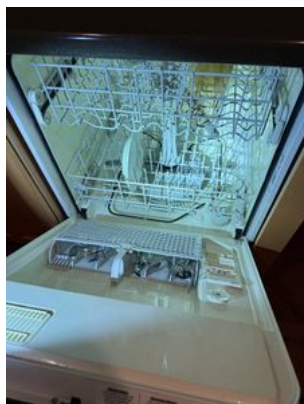
### Dishwasher

Whirlpool

Condition: Satisfactory

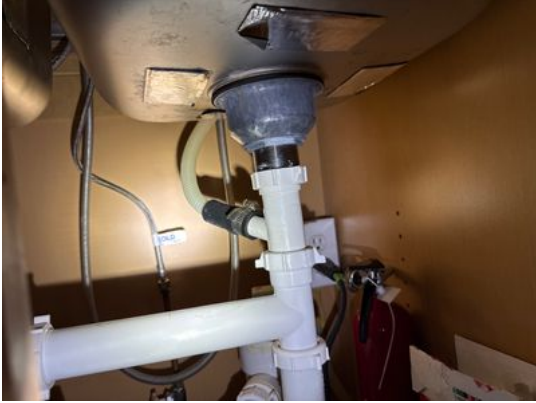
**High Loop Present**

Yes

Condition: Satisfactory
